PHASE I INSPECTION REPORT
NATIONAL DAM SAFETY PROGRAM

STORM LAKE DAM
ANACONDA, MONTANA
DEER LODGE COUNTY

HKM ASSOCIATES
BILLINGS, MONTANA

JUNE 1981

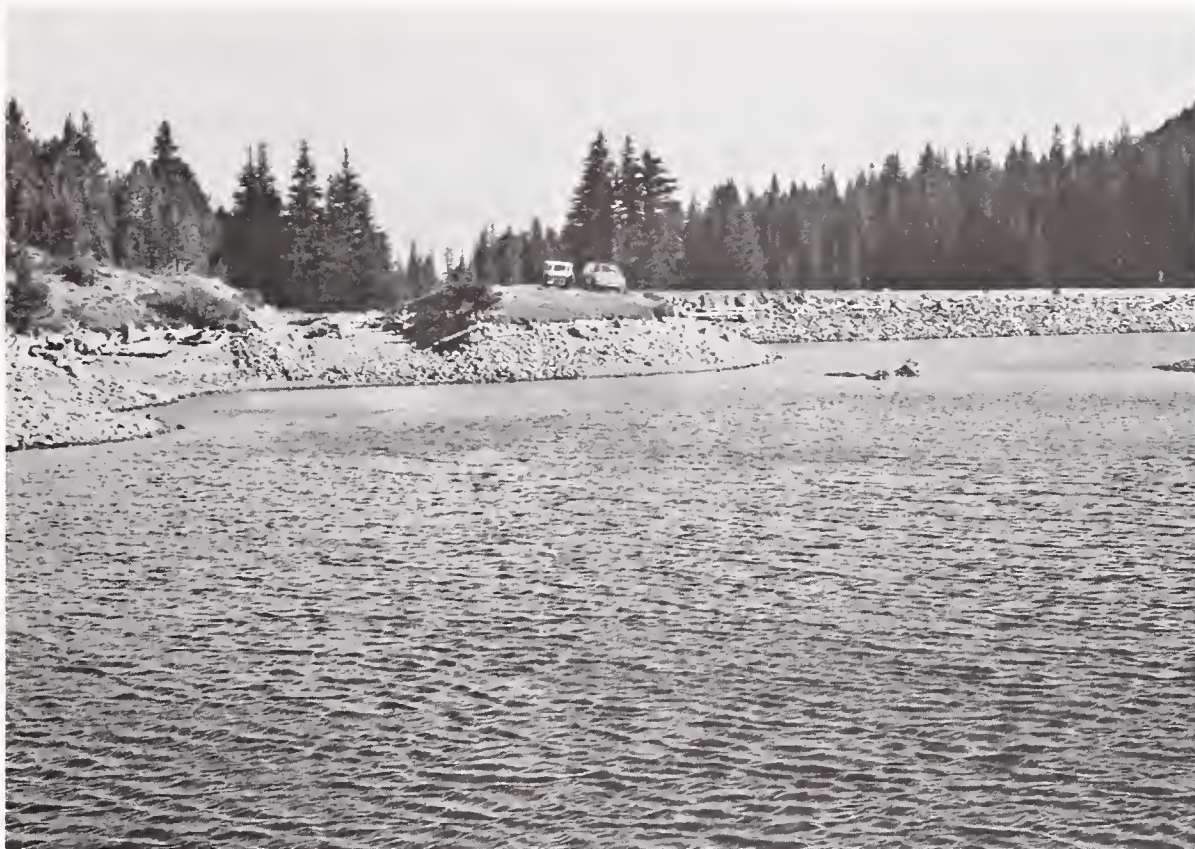
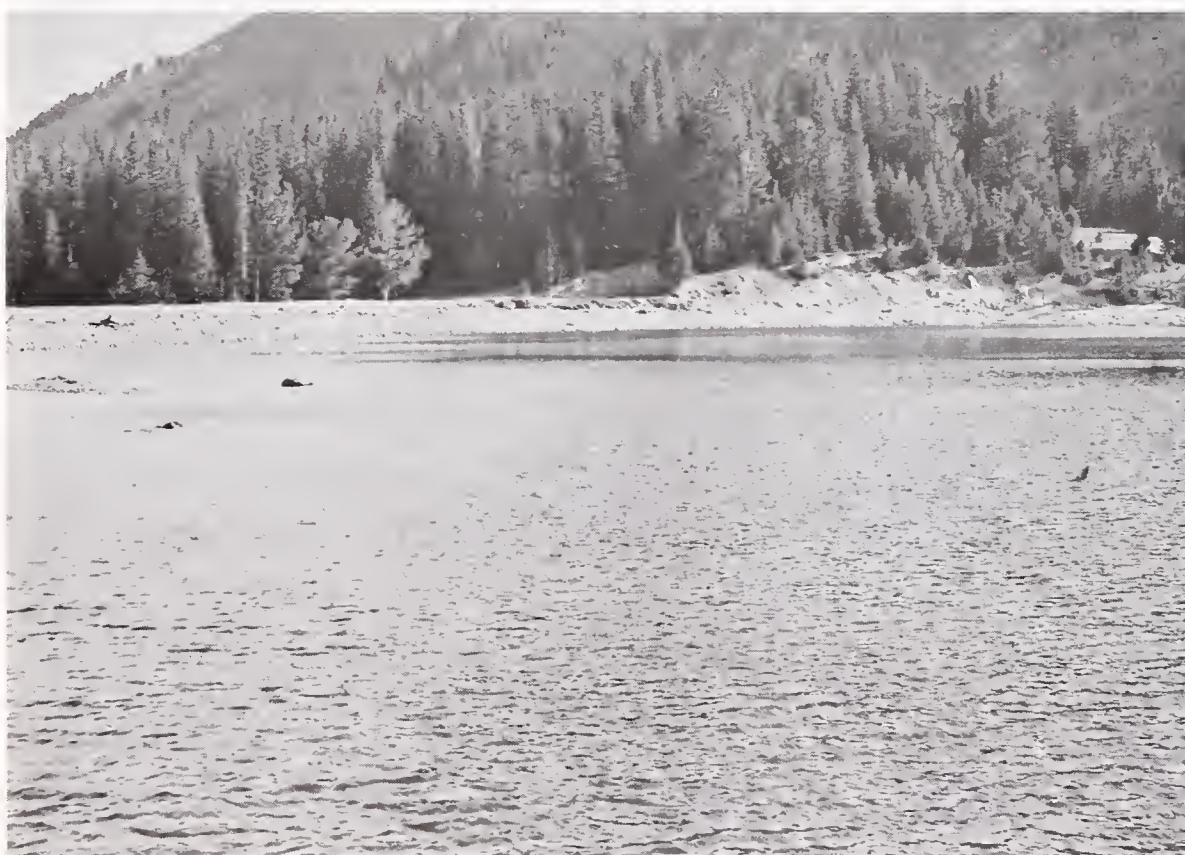
Photo No. 1 - Dam

Photos 1 and 2 are a pan of Storm Lake Dam. The spillway is located on the left (west) side of the dam. Timber debris is present in the spillway approach channel and along the spillway banks.

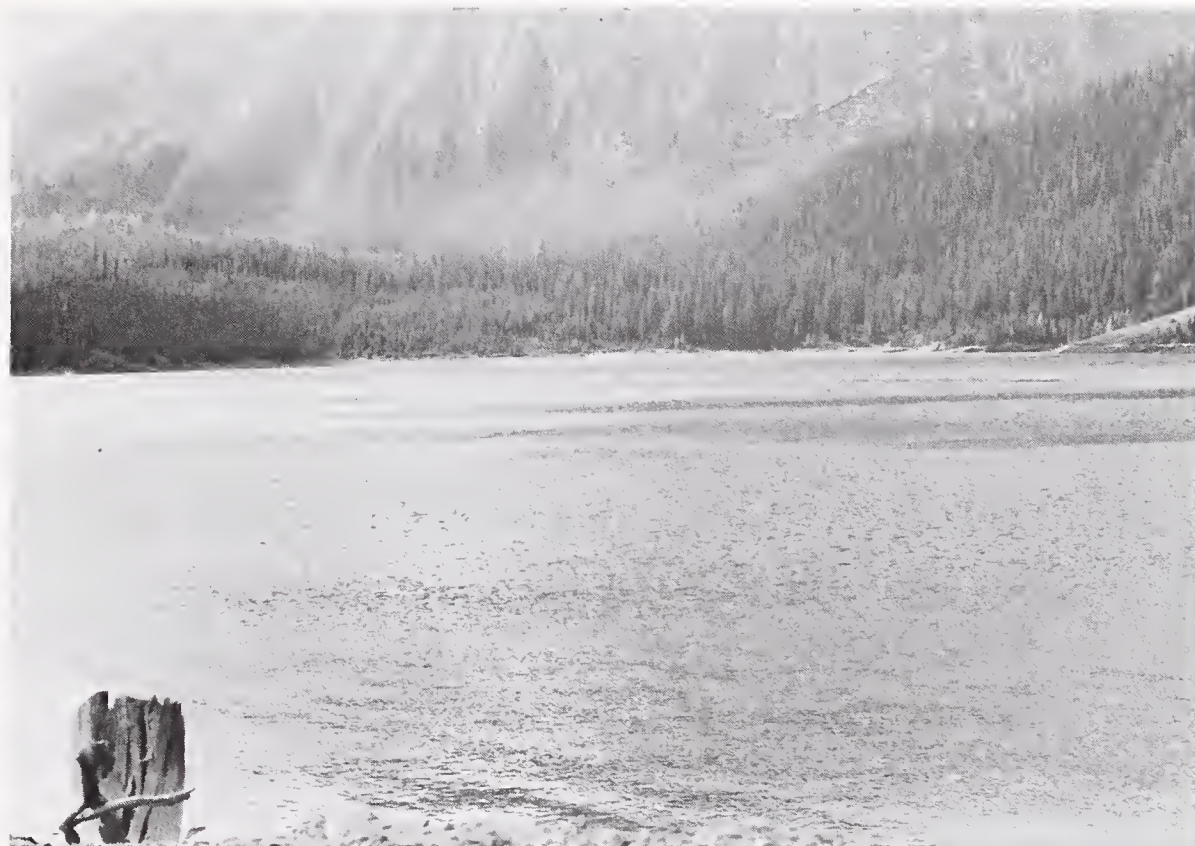
Photo No. 3 - Watershed
The upstream watershed consists of alpine terrain.

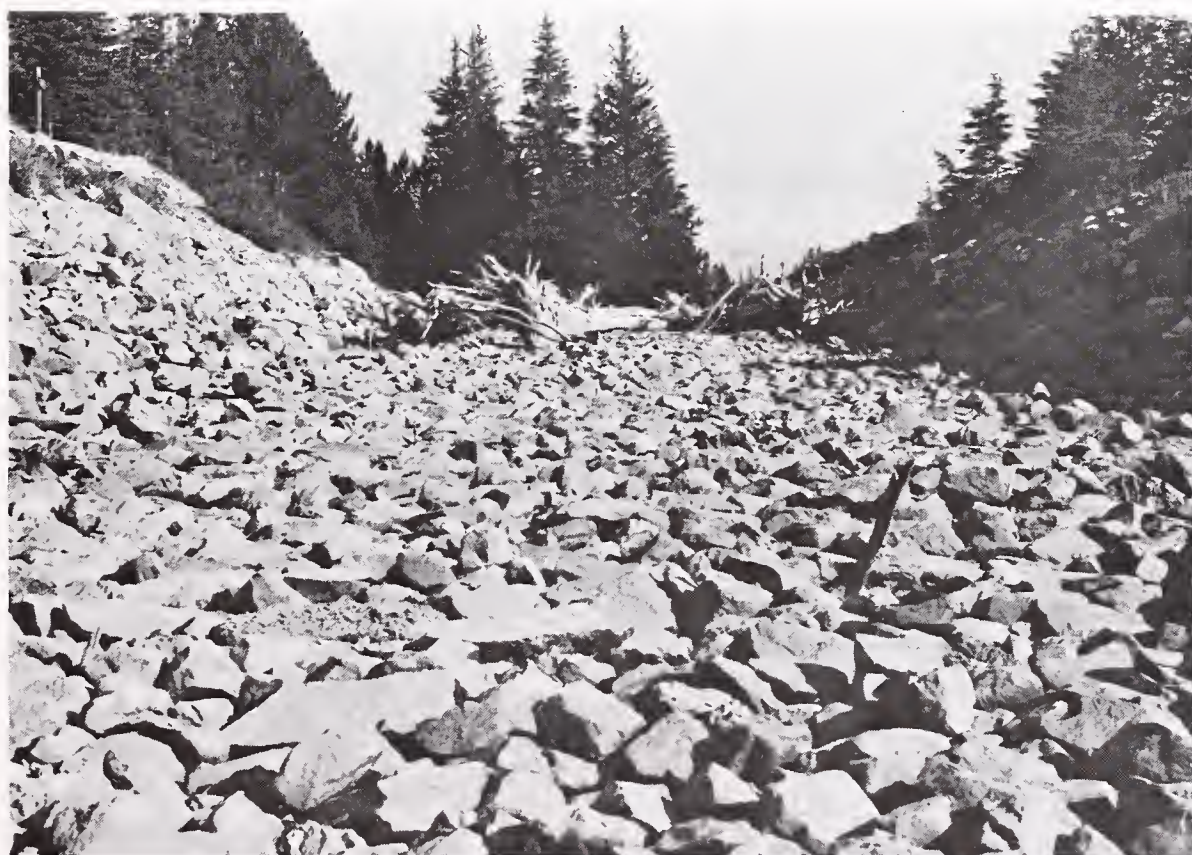
The spillway entrance and approach are in good condition. Minor riprap sloughing has occurred in the approach section. The approach section also contained a significant amount of debris. This debris consists primarily of timber carried down the steep basin slopes by snow avalanches each year. This timber debris is generally burned yearly, but was not burnt this year due to lack of personnel as the result of strikes. There is no log boom.

Photo No. 4 - Spillway
The spillway approach section is lined with rock.
Timber debris is present along the channel bottom.

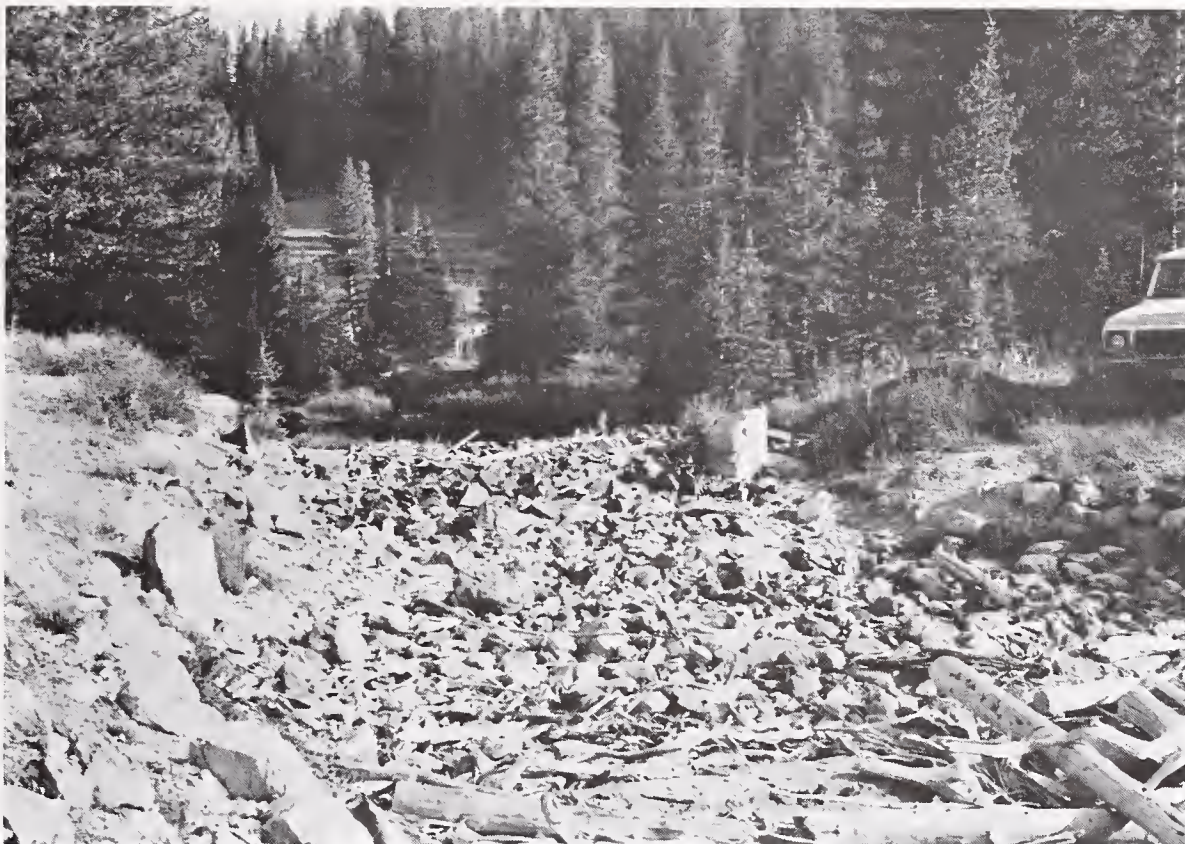
Photo No. 5 - Spillway

The concrete sill is in very poor condition. The concrete is experiencing cracking and spalling. At the time of the investigation, a large amount of timber debris was collected against the upstream side of the sill. As stated above, this material is generally burned yearly.

The concrete sill which performs as the spillway crest is in the foreground. At the time of the September 1980 survey it was nearly buried with timber debris. The spillway return channel begins at the break in slope where the riprap ends.

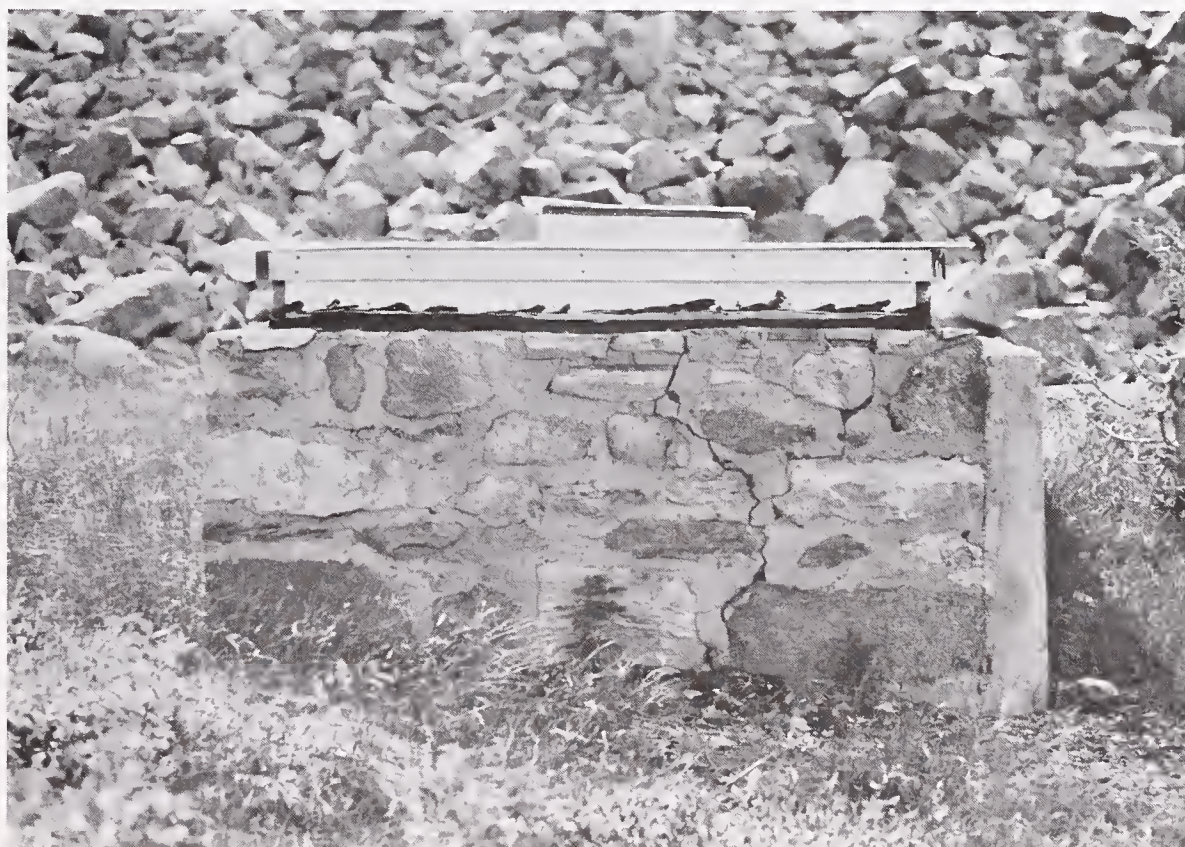
Photo No. 6 - Outlet Works

The exterior of the gatehouse has deteriorated significantly. Cracking, chipping and spalling is present in the concrete. Cracking of the mortar is evident throughout the rock (Photo 6 of Appendix B). The mastic or asphaltic material has separated from the joint between the wood roof and the masonry. Some of the wood material in the hatch cover has been eaten away by wood chucks. The interior of the masonry walls is also badly deteriorated. However, the gatehouse is in stable condition because of the large timber cribbing.

The exterior walls of the gatehouse are in poor condition. The mortar between the rocks is cracked and the sealant between the rock and the roof has separated.

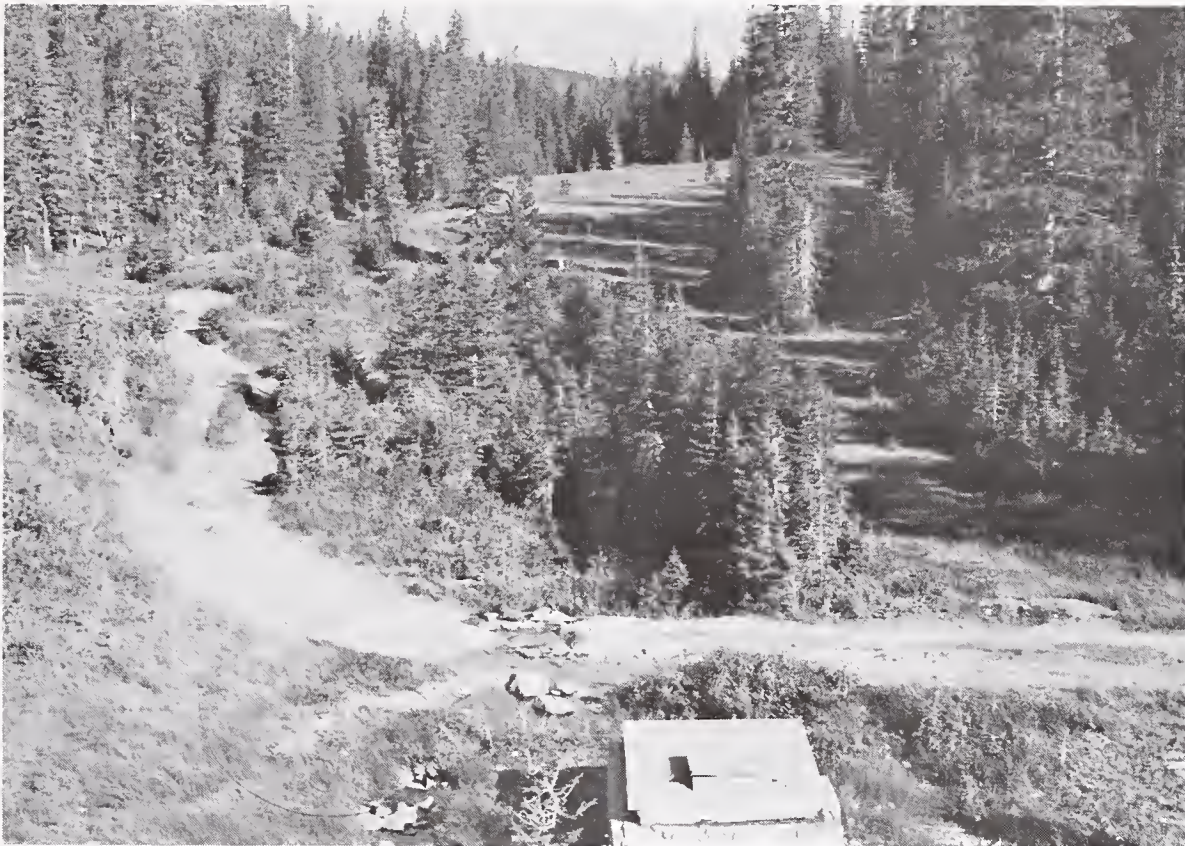
Photo No. 7 - Outlet Works

The gatehouse is located in the foreground. The outlet discharges into Storm Lake Creek across the road from the gatehouse. Seepage water from the dam is flowing adjacent to the gatehouse.

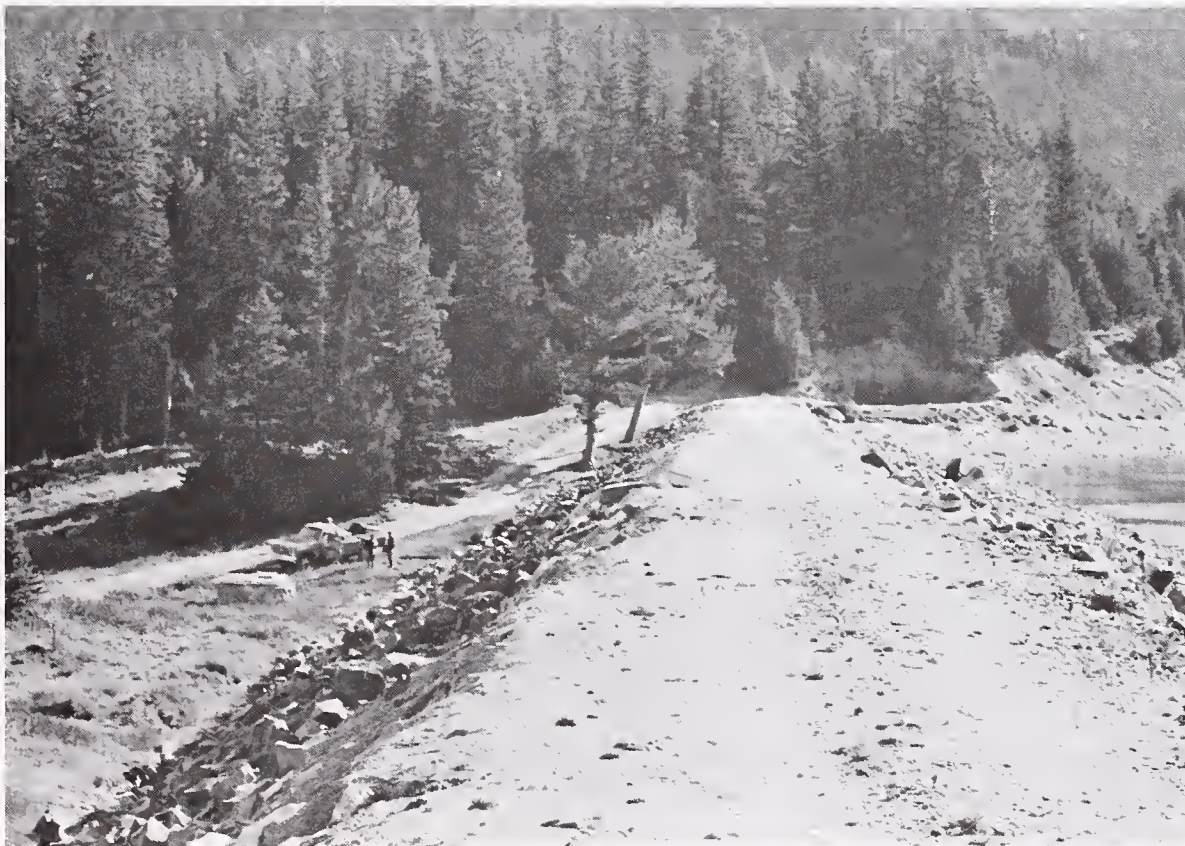
Photo No. 8 - Dam Embankment

This photo is looking along the dam crest towards the right (east) abutment. The clay/sand layer was placed on the crest in 1977. The measured crest width varies from 13 to 17 feet.

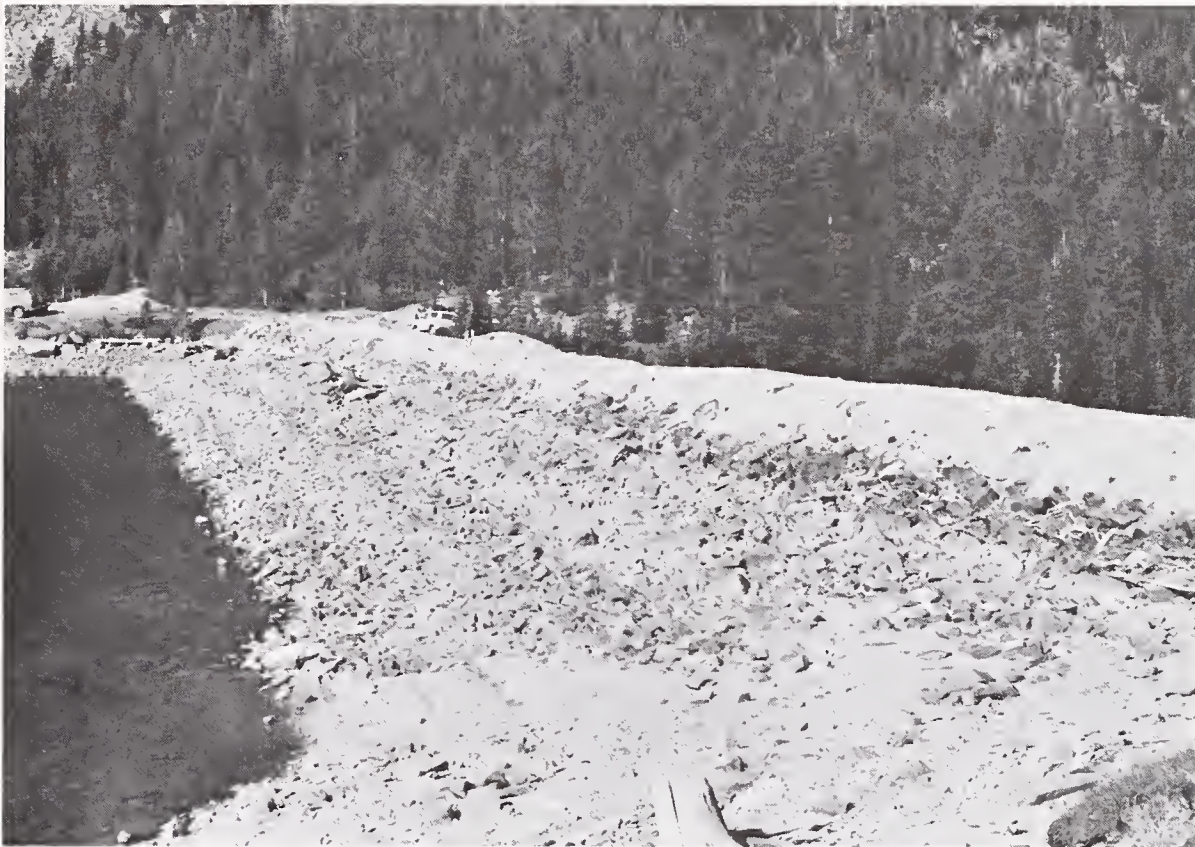
Photo No. 9 - Dam Embankment
Some debris is evident on the upstream slope of the dam. The clay/sand layer on the crest was placed in 1977.

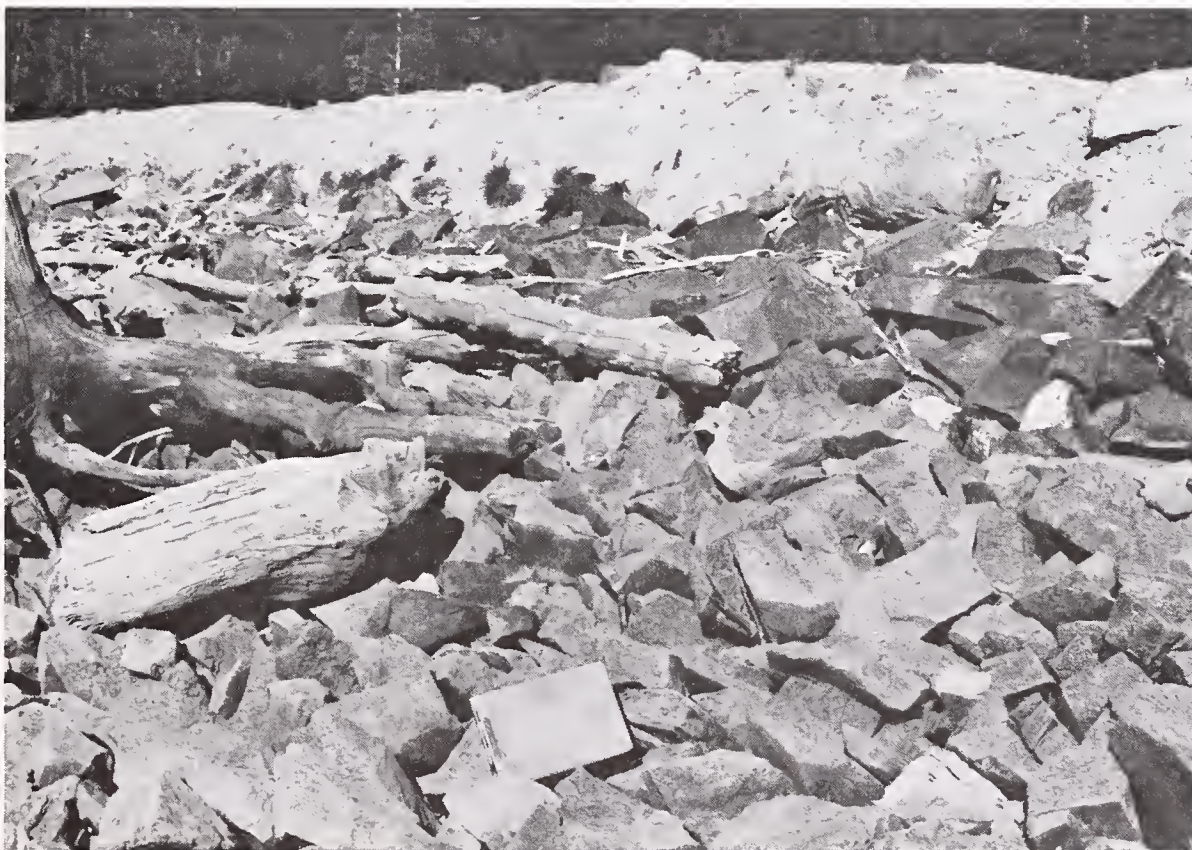
One of the available drawings (Sheet 2 of Exhibit C1) indicates the upstream face of the main dam embankment has a slope of 1V on 1.5H down to elevation 8318 feet (see note on page viii), then flattens to 1V on 3.5H. The drawings indicate there is a 7.5 foot wide bench located at elevation 8320 feet. The drawing also indicates that wave protection is provided by paving which appears to refer to loose rock riprap (Photo 9 of Appendix B). A slope of 27 degrees (1V on 2H) was measured on the existing slope above elevation 8318 feet and slope measurements below varied from 14 to 15 degrees (1V on 3.8H), which is also slightly flatter than shown on the plans. There was some scattered debris evident on the upstream slope (Photos 9 and 10 of Appendix B).

Photo No. 10 - Dam Embankment
The riprap consists of loose quartz and quartz monzonite, and is in excellent condition. Debris is evident on the upstream face.

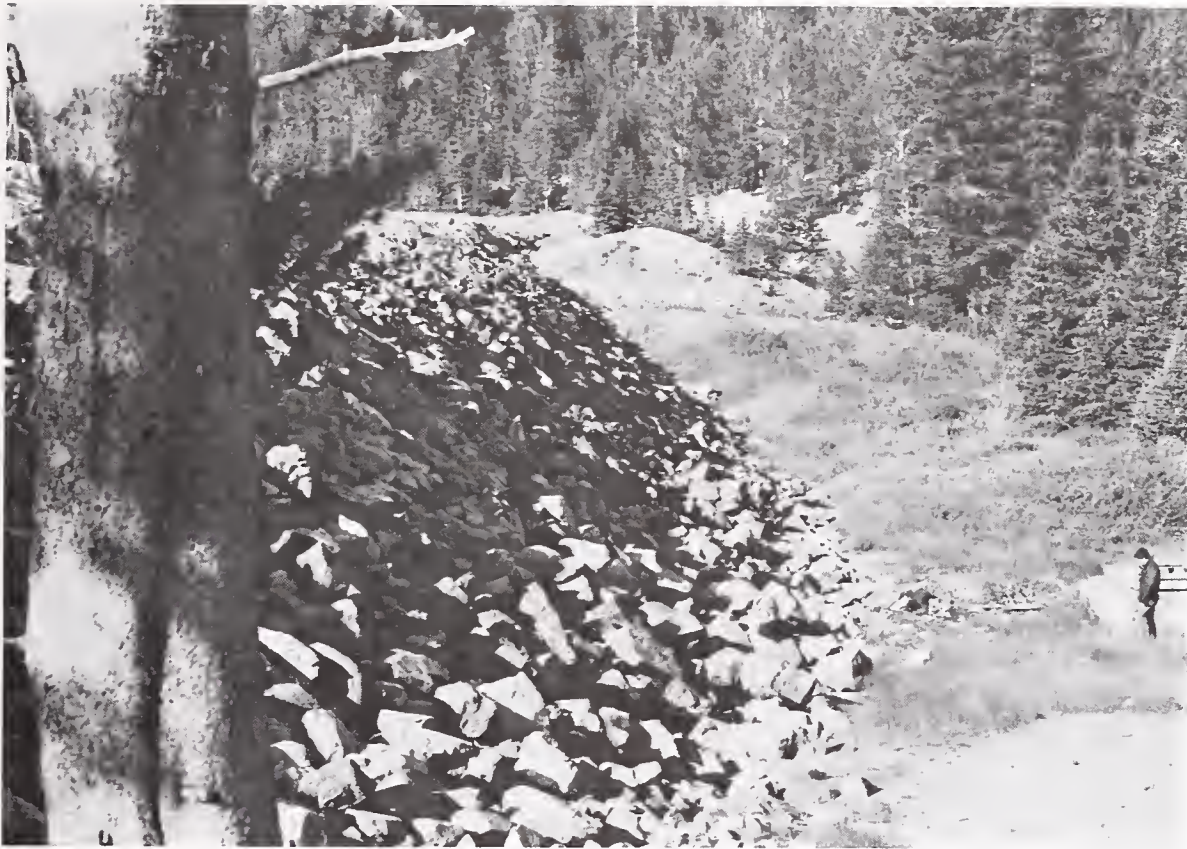
Photo No. 11 - Dam Embankment

The drawing indicates the downstream face of the dam was designed with a slope of 1V on 1.5H (Sheet 2 of Exhibit C1). Field measurements averaging about 33 degrees verify this slope. The surface of the downstream slope was loose rock (Photo 11 of Appendix B). This slope was relatively uniform.

The embankment is earth and rock fill and appears stable. The downstream face of the embankment has a slope of about 33 degrees or 1V on 1.5H.

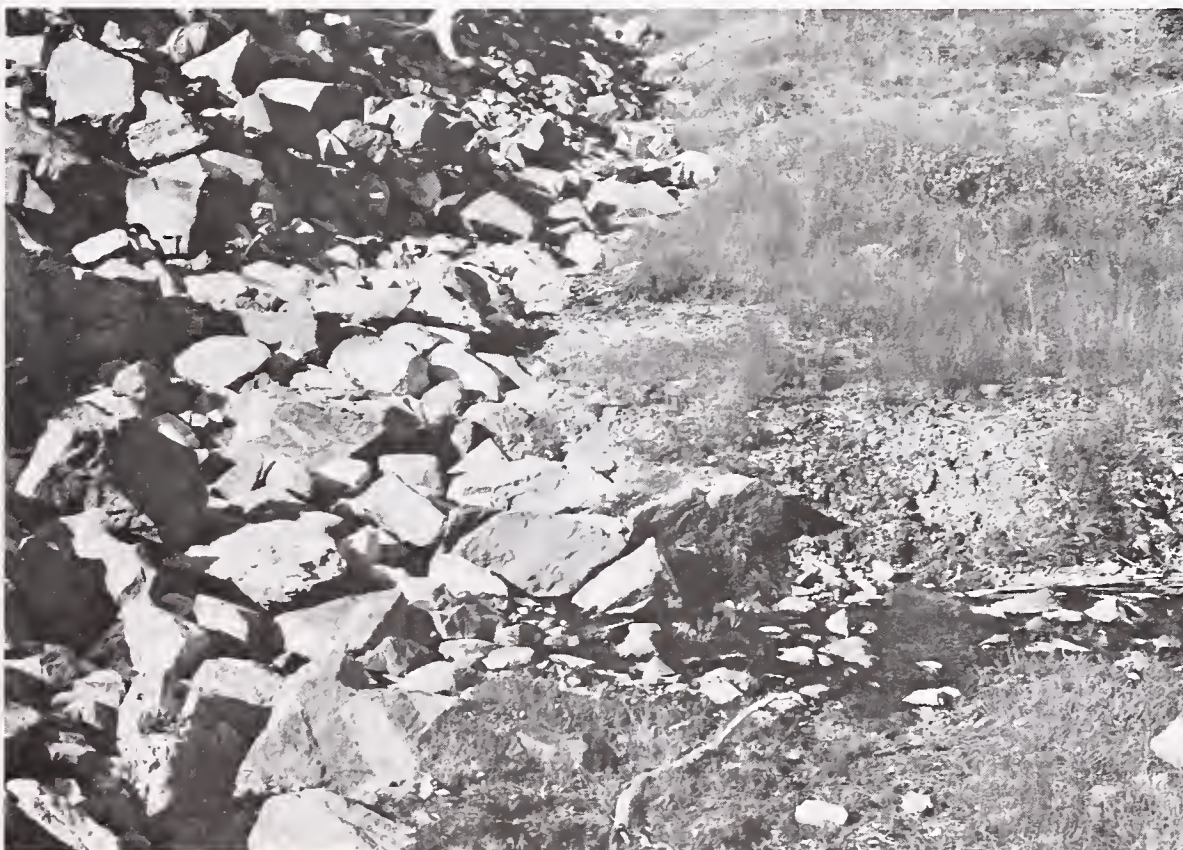
Photo No. 12 - Dam Embankment

High seepage flows are evident at the downstream toe of the dam. Seepage water is shown exiting from the lowest point on the downstream slope.

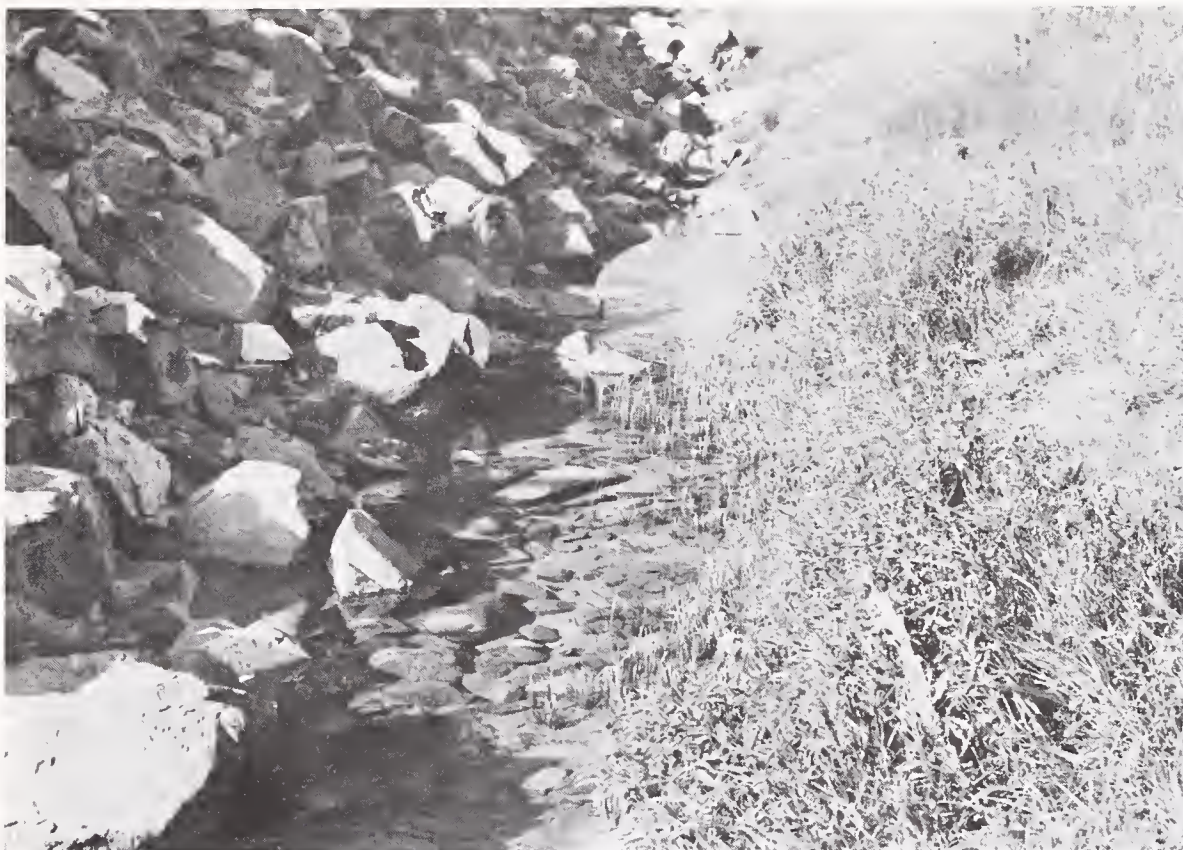
Photo No. 13 - Dam Embankment
Seepage water is ponded at the downstream toe of the dam.

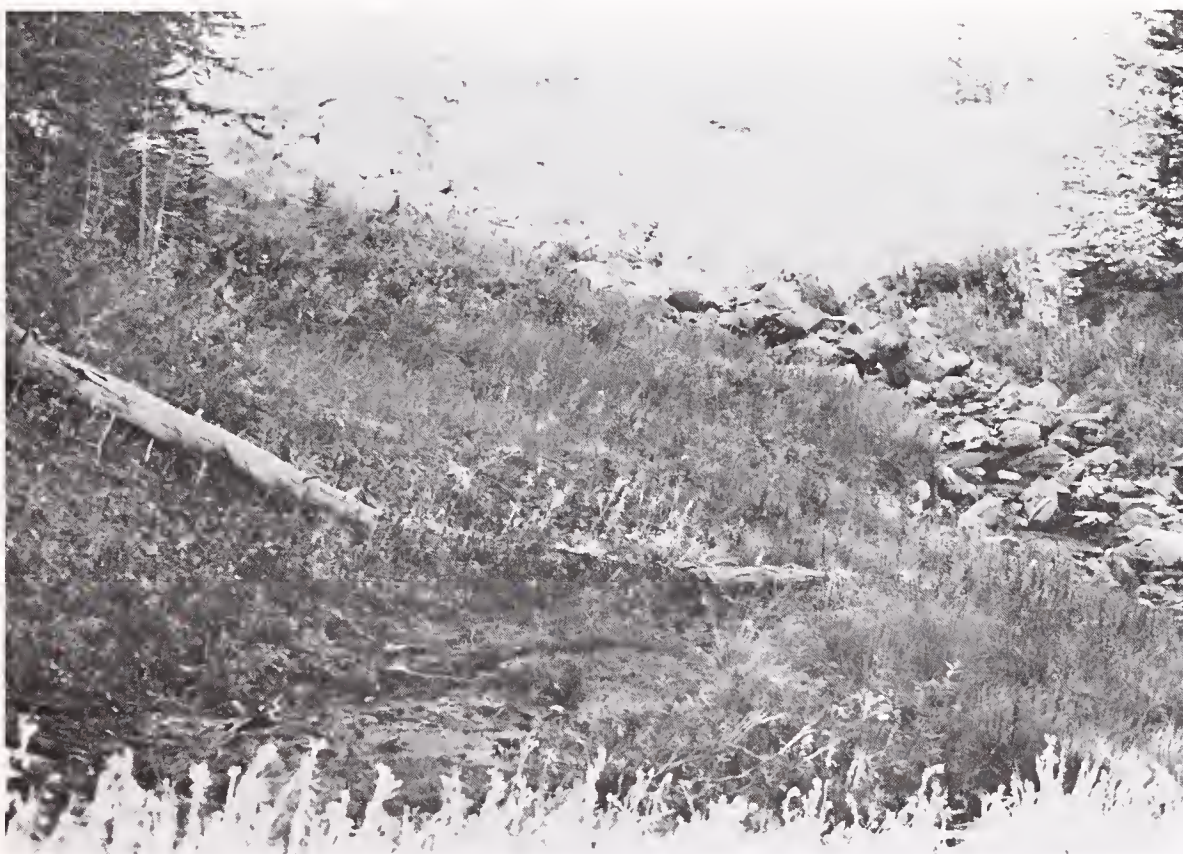
Photo No. 14 - Dam Embankment
High seepage flows are evident through the abutments and under the dam. Free flowing springs are shown here approximately 75 feet below the left abutment. The ground is saturated throughout the valley floor immediately below the dam.

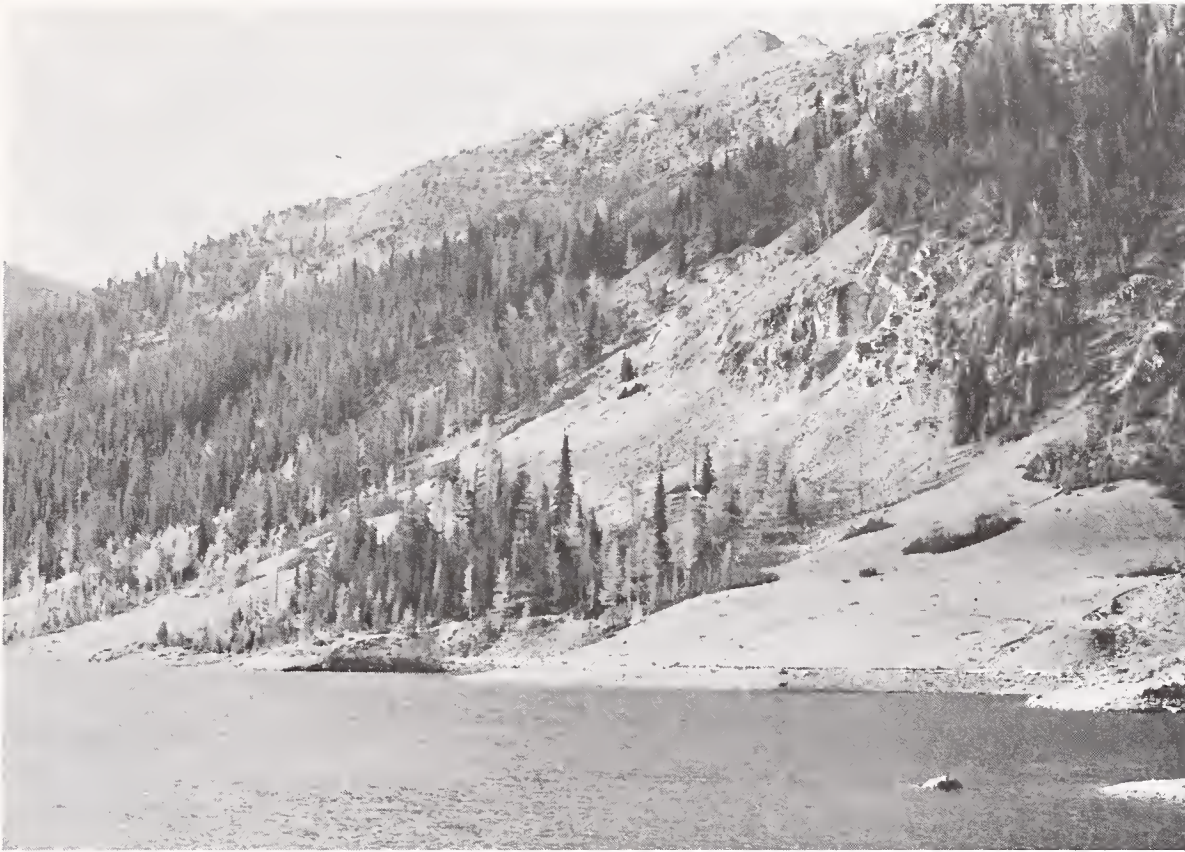
Photo No. 15 - Reservoir

Large snow slides and minor land slides have occurred along the reservoir shoreline (Photo 15 of Appendix B). The snow slides are potentially dangerous as one could create a large wave which may overtop the embankment. The shoreline was occasionally vertical, or near vertical, to heights of about 10 feet and localized sloughing occurs due to wave action and saturated conditions.

Snowslides and small landslides have occurred along the reservoir shoreline. The reservoir banks are near vertical to heights of about 10 feet in places.

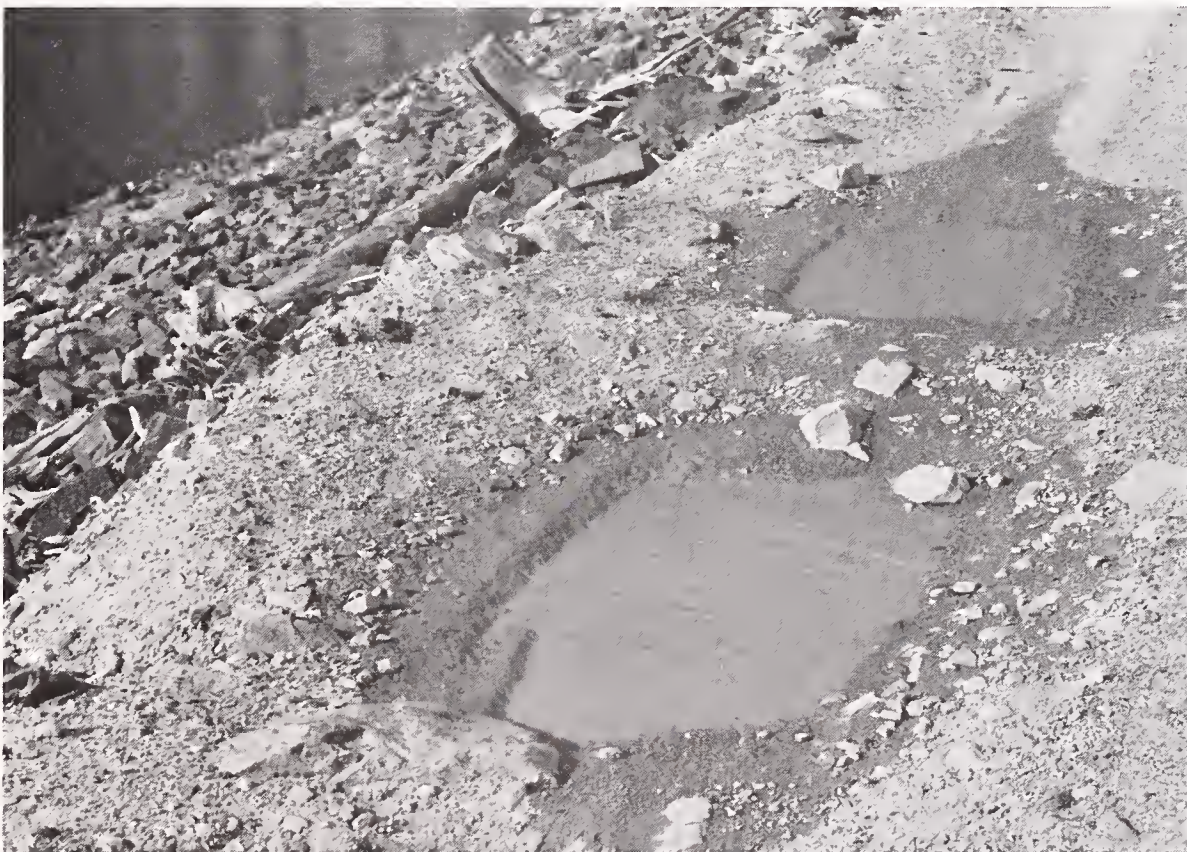
Photo No. 16 - Dam Embankment

There are several locations along the crest where water has ponded in depressions caused by vehicular traffic. At locations where water has spilled from these ponds down the slope, small erosion gullies have formed (Photo 16 of Appendix B). These gullies do not create a safety hazard.

Water is ponding on the crest in several locations. Runoff or spillage of ponded water is causing some erosion in the sand as can be seen in the far left of this photo.
